Multidisciplinary study of flash floods in the Caldera de Taburiente National Park (Canary Islands, Spain)

M. Génova^{a,*}, P. Máyer^b, J. Ballesteros-Cánovas^{c,d}, J.M. Rubiales^a, M.A. Saz^e, A. Díez-Herrero^f

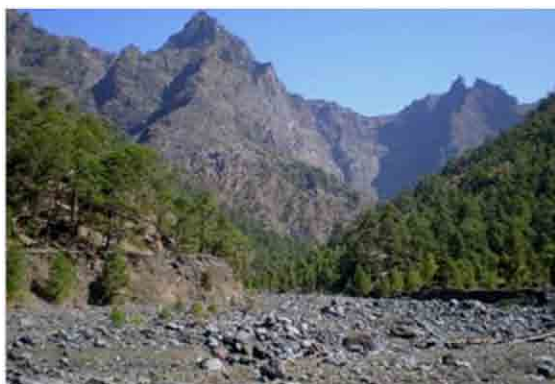
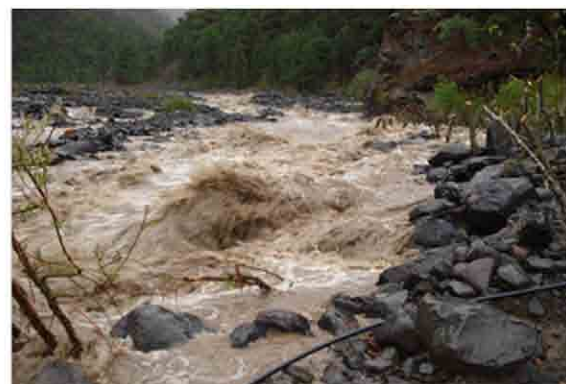
Fig. 2. View of the valley bottom of the Taburiente river gorge (left) and the same reach during a flash flood in 2009 (right) (Right photo: Ezequiel Alfonso).

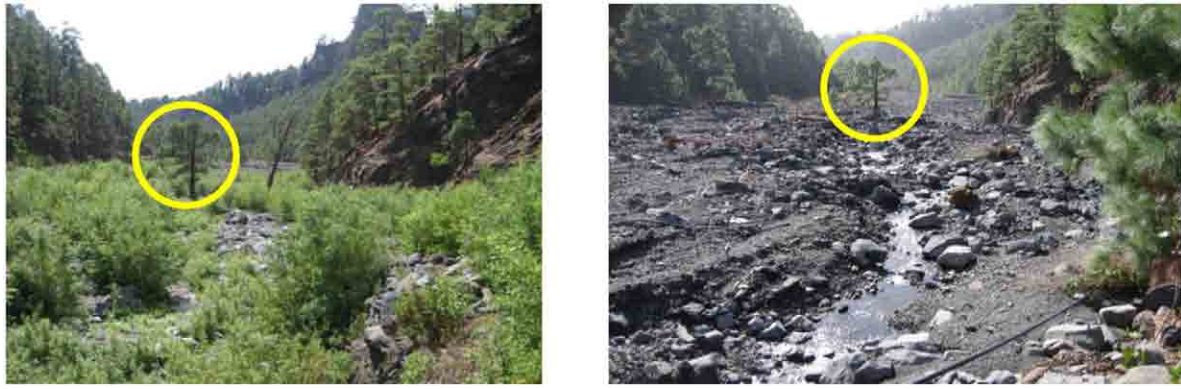
Fig. 3. Reforestation with *Salix canariensis* before (left) and after (right) the 2010 flash flood event in Verduras de Alfonso gorge (Photos: Ángel Palomares). Take as reference the *Pinus canariensis* in the centre of the valley bottom.

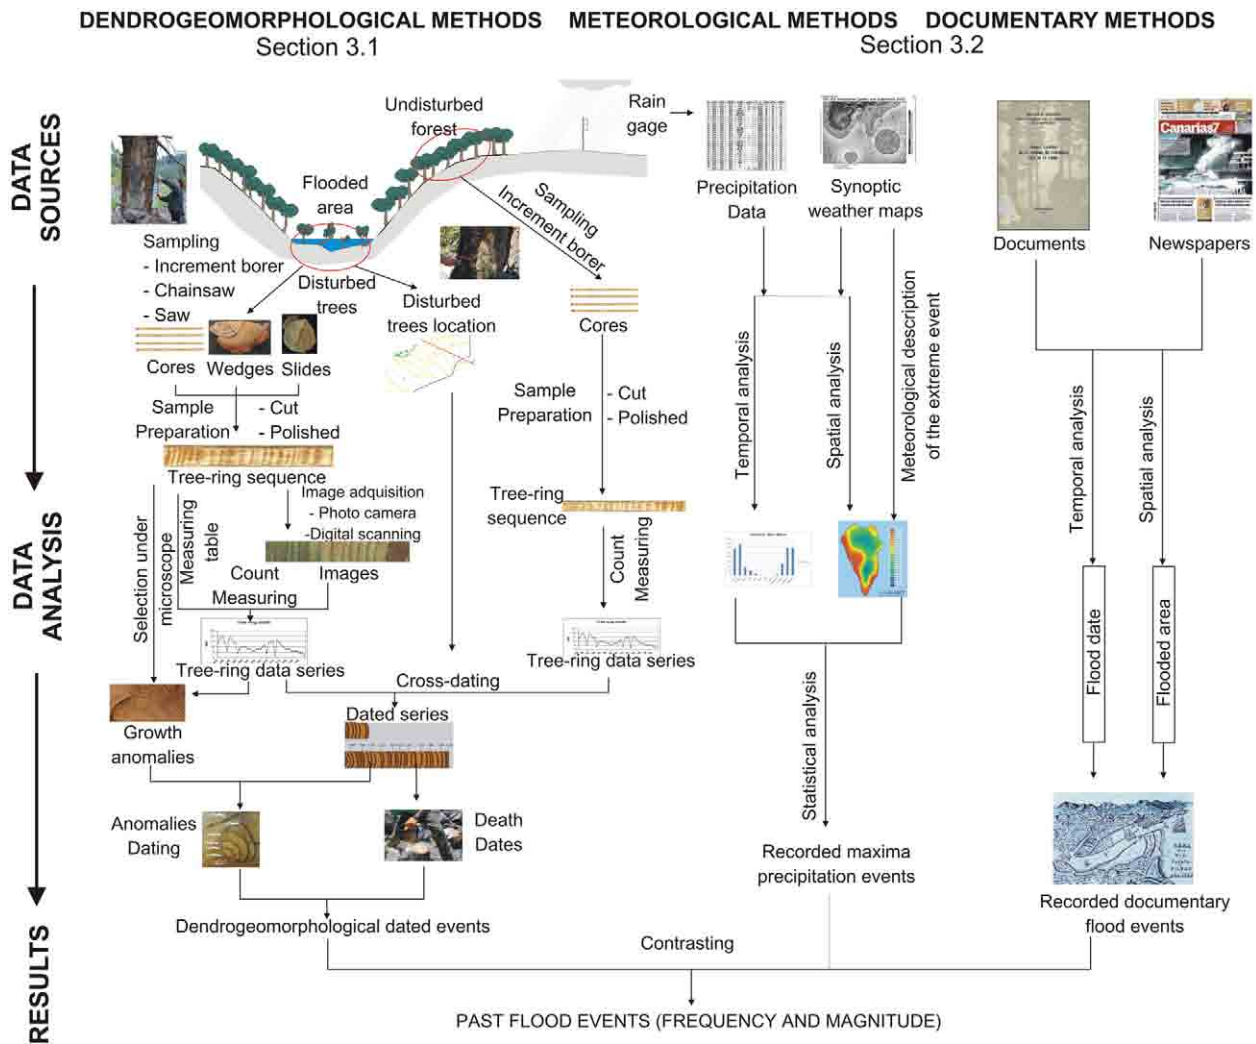
Fig. 4. Methodological synthesis.

To carry out the abovementioned study, simultaneous and complementary analysis and synthesis based methodological approaches are adopted, with a sequential combination of field data acquisition methods, in-laboratory study protocols, and desk-based processing and analysis methods (Fig. 4).

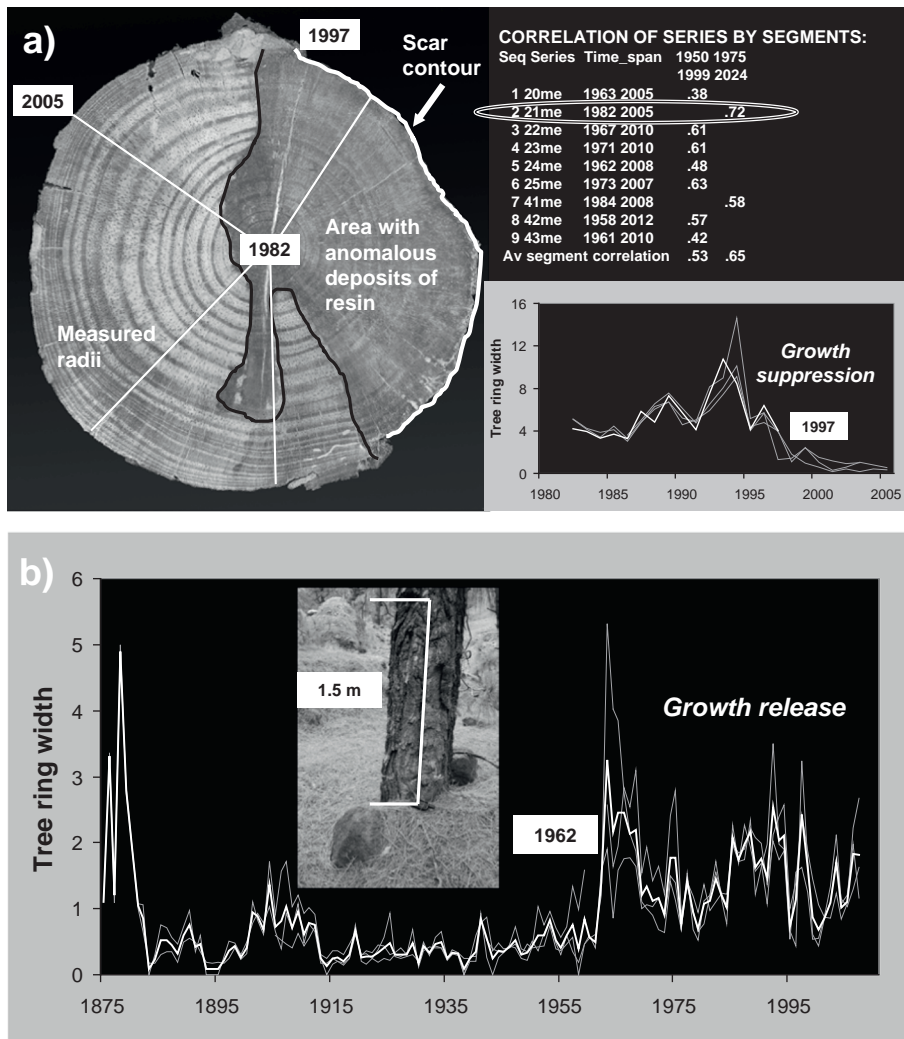
Fig. 6. Examples of tree response to damage. a) Growth suppression ending with death of the tree: cross section showing anomalous resin deposits (left), the series correlation with nearby trees (right and above) and graphics of measured radii (right and below). b) Growth release, commonly detected in old trees after 1962 damage, and a picture showing a large scar.

Once the samples had been dried and prepared, rings were measured (with accuracy 1/100 mm) using the Lintab measuring system and associated Tsap software (Rinn, 2003). For the cross sections or wedges, a minimum of four radius measurements per sample were made (Fig. 6a).

- Growth suppression, in some cases ending with tree death (Fig. 6a).
- Growth release, probably as a result of a large amount of reaction tissue formation, commonly detected in old trees after the 1962 damage (Fig. 6b).

Dendrogeomorphological evidence of flash flood events was compared with growth release and we found that there was a relationship, especially in cohort 1 (the older trees) (Figs. 6b and 8). Thus, other hypothetical dates for flash floods based on releases were searched for and are indicated in Fig. 8. Altogether, this evidence suggests a mean flash flood time interval of 14–15 years. The damage recorded later increased in frequency and the time interval over the last twenty years is 3–4 years, although with much less replication.

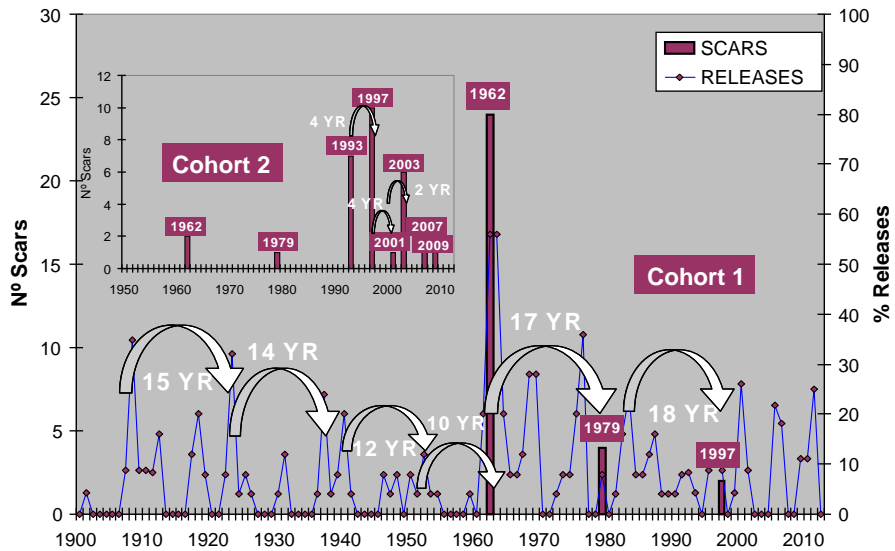
Fig. 8. Evidence of injury and time interval.

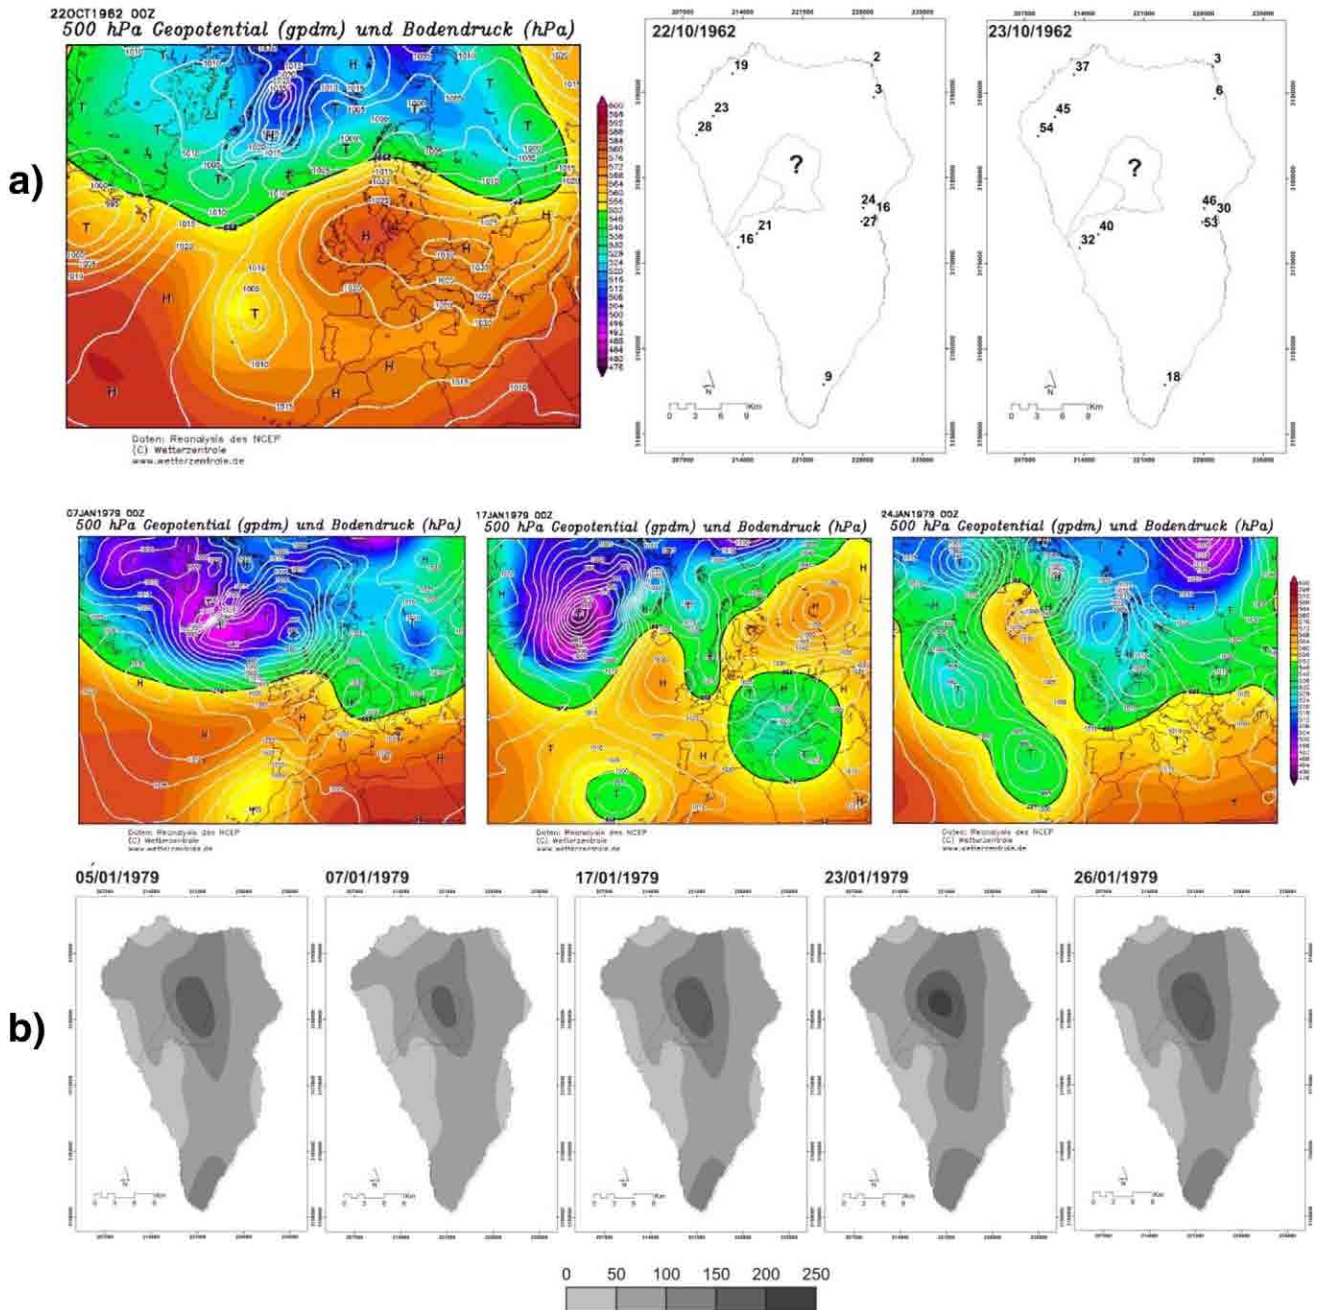
Fig. 11. a) 1962 event: 500 hPa weather map, surface isobars and precipitation records on the La Palma island. b) 1979 event: 500 hPa weather map, surface isobars and rainfall distribution on the La Palma island.

we searched for data from other meteorological stations on La Palma island to corroborate the existence of this heavy rainfall event (Fig. 11a).

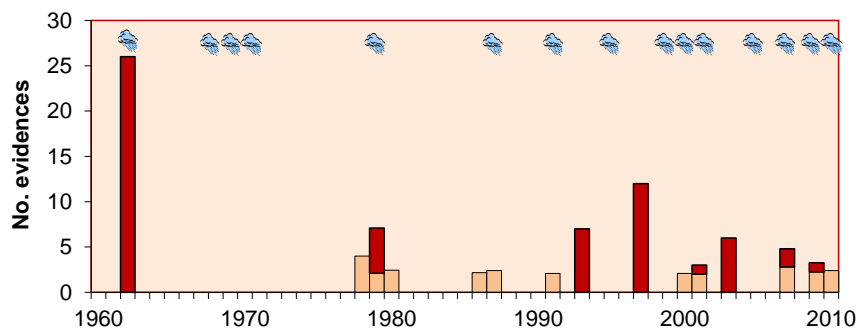
Fig. 12. Compilation of multidisciplinary proxies of flash flood events available for the past 50 years. Red column: number of damaged trees; orange column: rainfall ≥ 200 mm/24 h/100.

Fig. 12 compiles the information available for the past 50 years, including the flash floods recorded from damaged trees and in other flash flood proxies, such as meteorological data and documental sources. Among the flash floods dated by dendrogeomorphological techniques, those in 1962, 1979, 2001, 2007 and 2009 match other data sources.
